FEAP-TR-N-92/04  
March 1992

## Application of Carbon Dioxide Treatment To Manage Scale in Building Potable Water Systems

by  
Richard J. Scholze, Prakash M. Temkar, Ken Rainwater, and John Harwood  
U.S. Army Construction Engineering Research Laboratory  
Champaign, IL 61824-4005

U.S. Army Engineering and Housing Support Center  
Fort Belvoir, VA 22060-5516

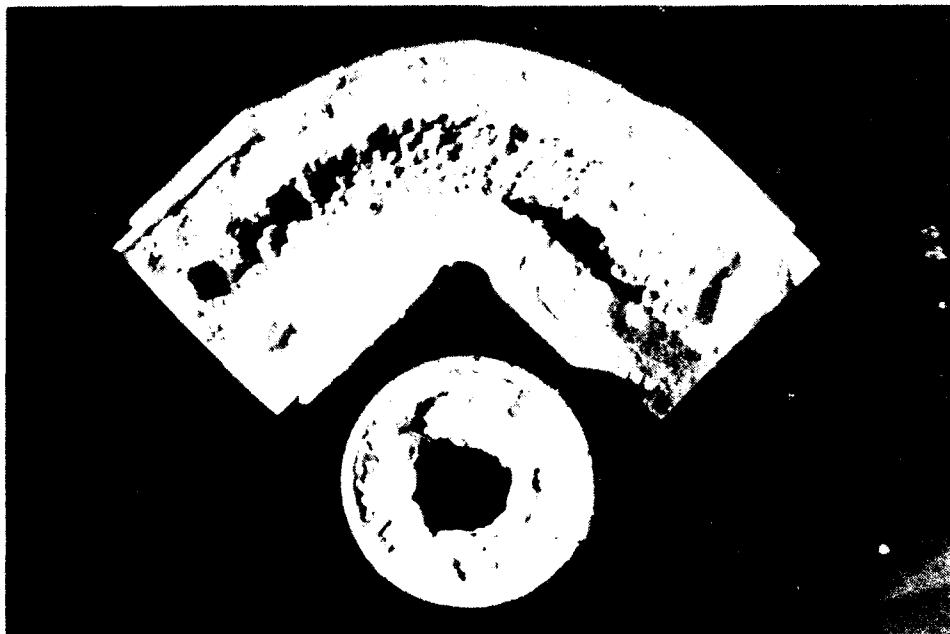
Scale formation (Figure 1) in potable water treatment and distribution systems usually is the direct result of a hard water supply. Hard water is common throughout many areas of the United States, Europe, and Asia where Army installations are located. The results of untreated or improperly treated hard water include clogged water distribution lines in buildings (especially hot water lines), increased operating expenses due to inefficiencies, excessive downtime and maintenance, and shortened life expectancies for many system components. Scaling is most prevalent in domestic hot water (DHW) heat exchangers, storage tanks, and plumbing systems of buildings. The most common type of scale in drinking water systems is composed of calcium carbonate.

Figure 1. Example of scaled pipe (copper).

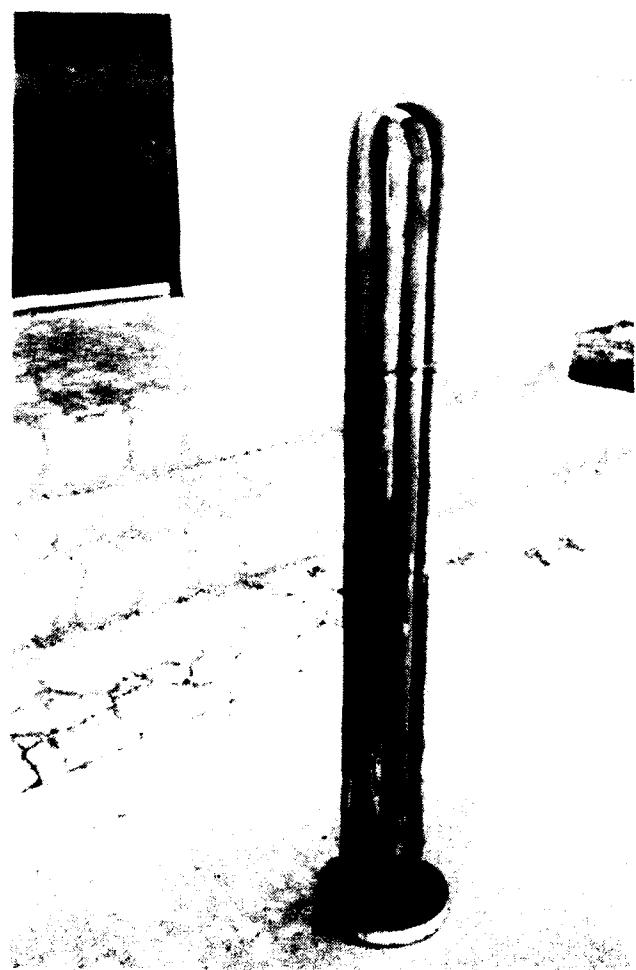
**Figure 8. Fort Ord scaled heat exchanger.**

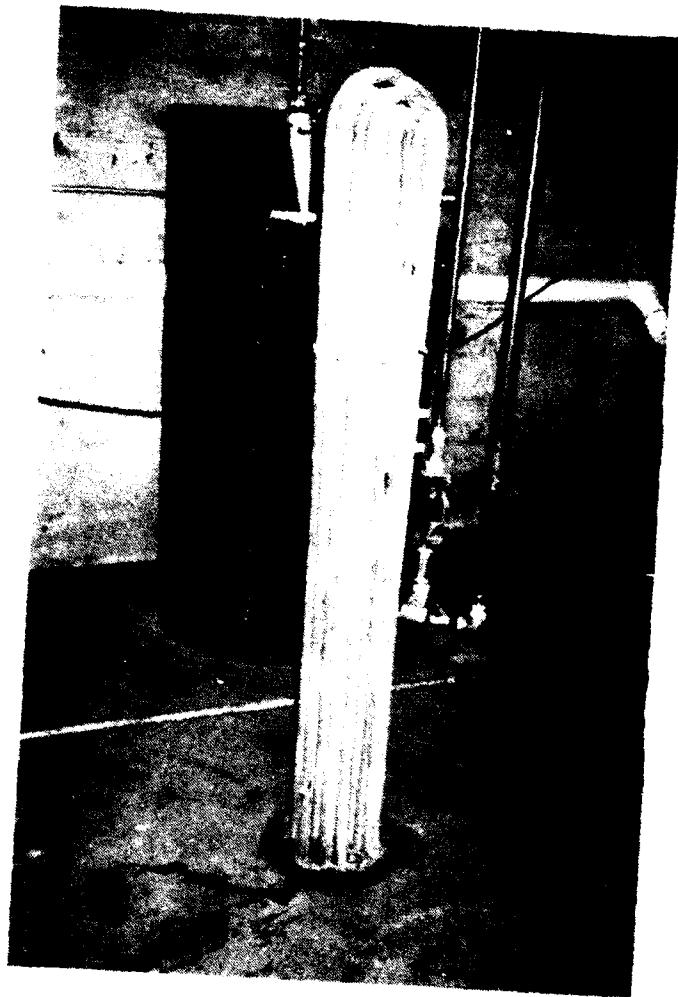
**Figure 11.** Dugway Proving Ground scaled heat exchanger before treatment.

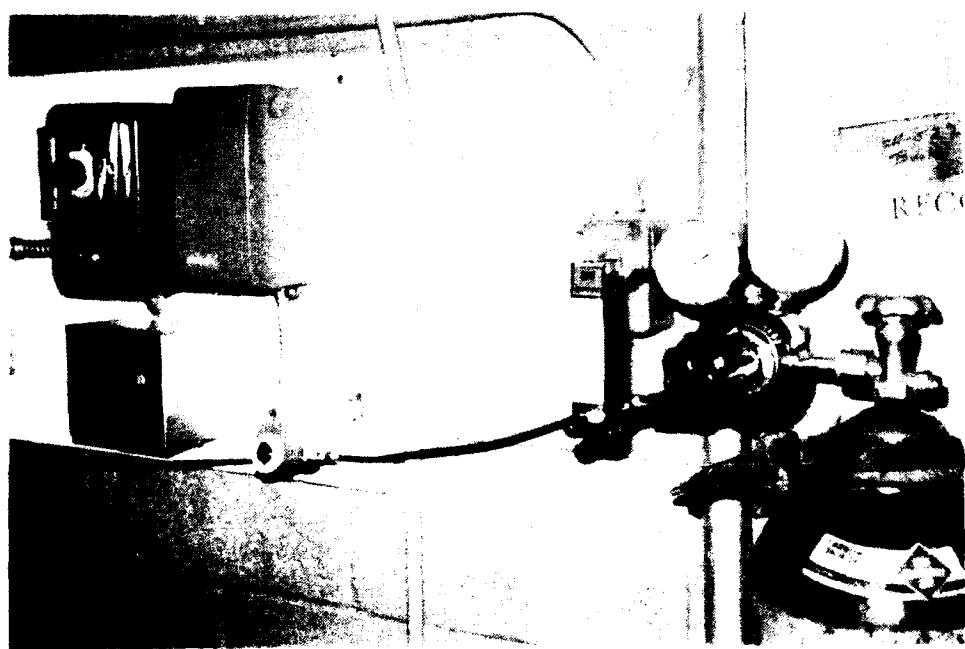
The installation monitor reported that the system had functioned properly until September 25. At this time, a problem with the treatment system occurred when the pressure in the carbon dioxide tank decreased from 900 psi to 25 psi within 2 weeks. This rate of depletion was not anticipated since the tank contained about 40 lb of gas which should have lasted more than 1 year at the set treatment rate (25 to 30 mg/L). The most probable reason for sudden loss of pressure was leakage in the gas lines used for injection into the water system.

Figure 16. Carbon dioxide tank and regulator setup.

Although the joints had been checked for leaks during initial installation, some leaks may have developed later, perhaps due to temperature changes inside the room. The furnace that generates steam had been turned on for the winter heating season about the time the leaks developed. This increased the temperature inside the room by 20 to 30 °F, which may have caused expansion in the joints where the leaks developed.

The leaks in the gas line were repaired by wrapping the joint threads with teflon tape and retightening the joints. All swagelock connections were checked again for leaks. A procedure for detecting and correcting gas leaks was established for the installation personnel who operate the carbon dioxide treatment system.

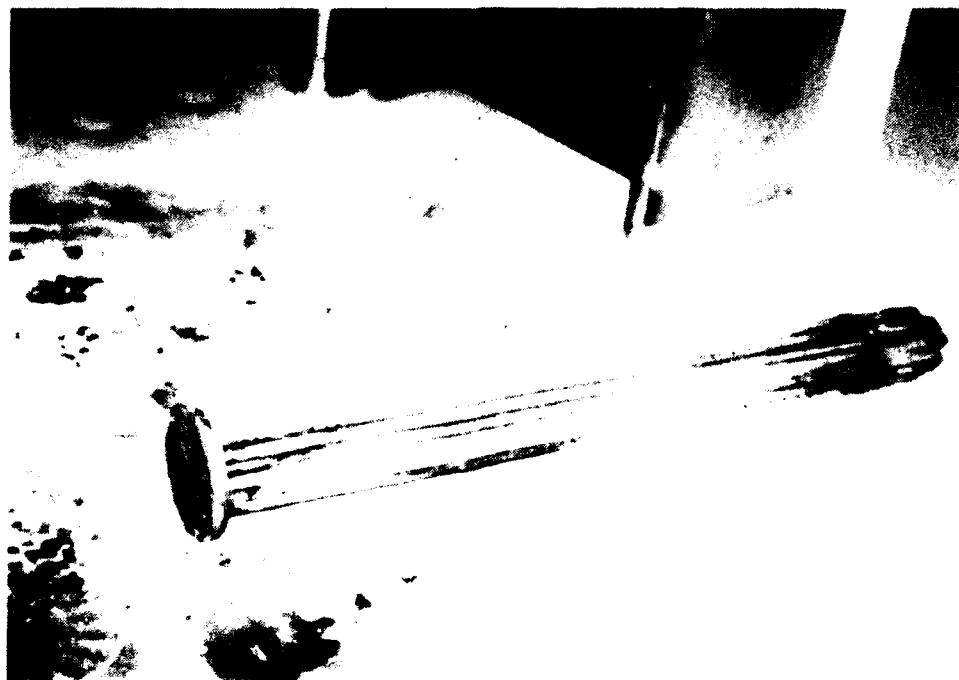
Figure 17. Heat exchanger after carbon dioxide treatment.

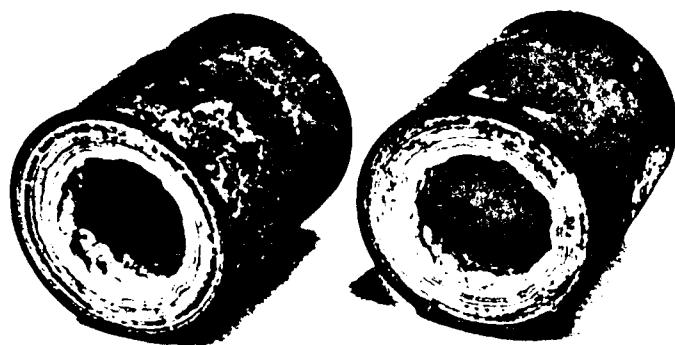
The inside diameter of the pipe is 2.5 in., and approximately 0.5 in. of scale had accumulated around the circumference. A sample of the pipe was sent to USACERL for analysis. In a simple test to identify carbonate scale, a small piece of the scale was placed in 1 N hydrochloric acid. The scale effervesced due to carbon dioxide formation and eventually dissolved completely, indicating the scale was predominantly carbonate minerals. Since the artificial scaling process failed, the pipe from Drane Hall was cut into 3-in. sections for use in the pipe manifold experiments.

Figure 22. Scaled pipe samples from Drane Hall.

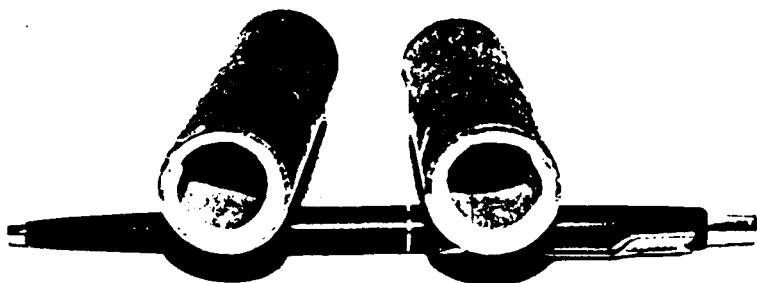
Figure 26. Scaled pipe samples from Doak Hall.

It appears from the laboratory experiments that a pH level between 7.0 and 7.5 will be sufficient to dissolve the scale. Since the system is old, a pH of 7.4 will be used as the target to cause slow dissolution, requiring a carbon dioxide dose of approximately 20 mg/L. The carbon dioxide will be injected near the suction side of the recirculation pump. This arrangement allows low-pressure injection and makes the system very accessible.
